Informal Flight Test 1 Review

Full System Flight Test utilizing Commercial Aerotech M1340W

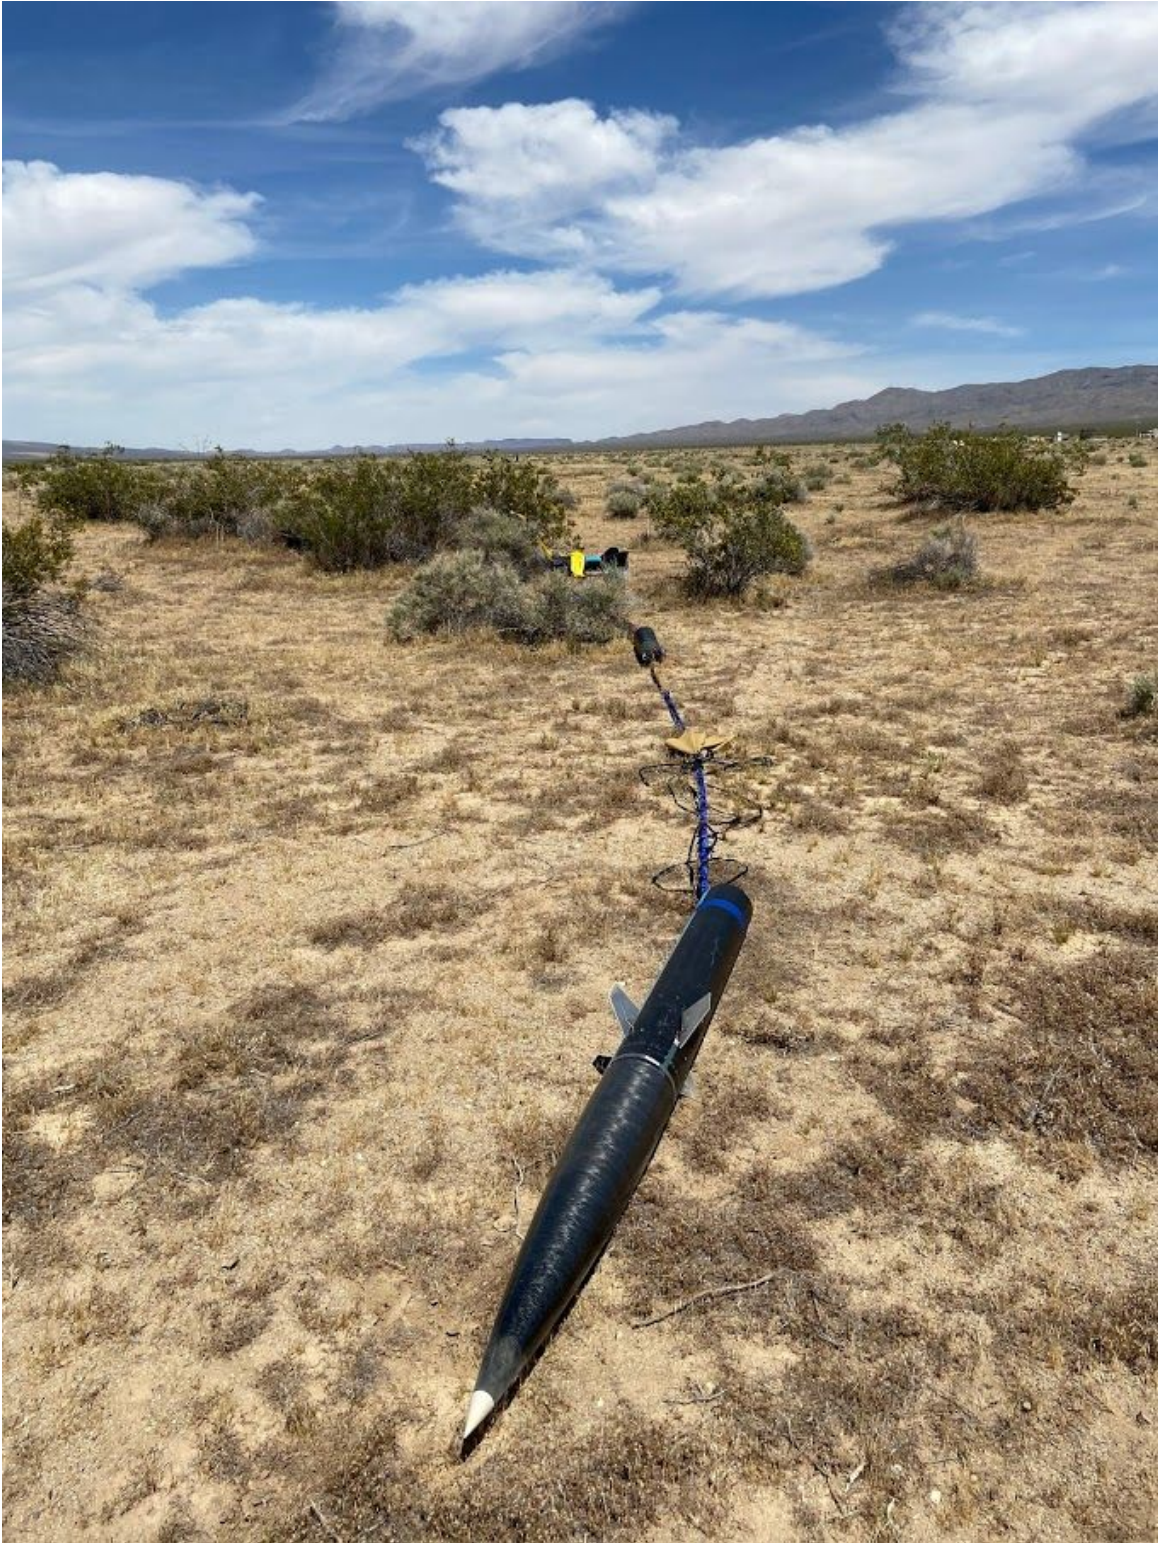
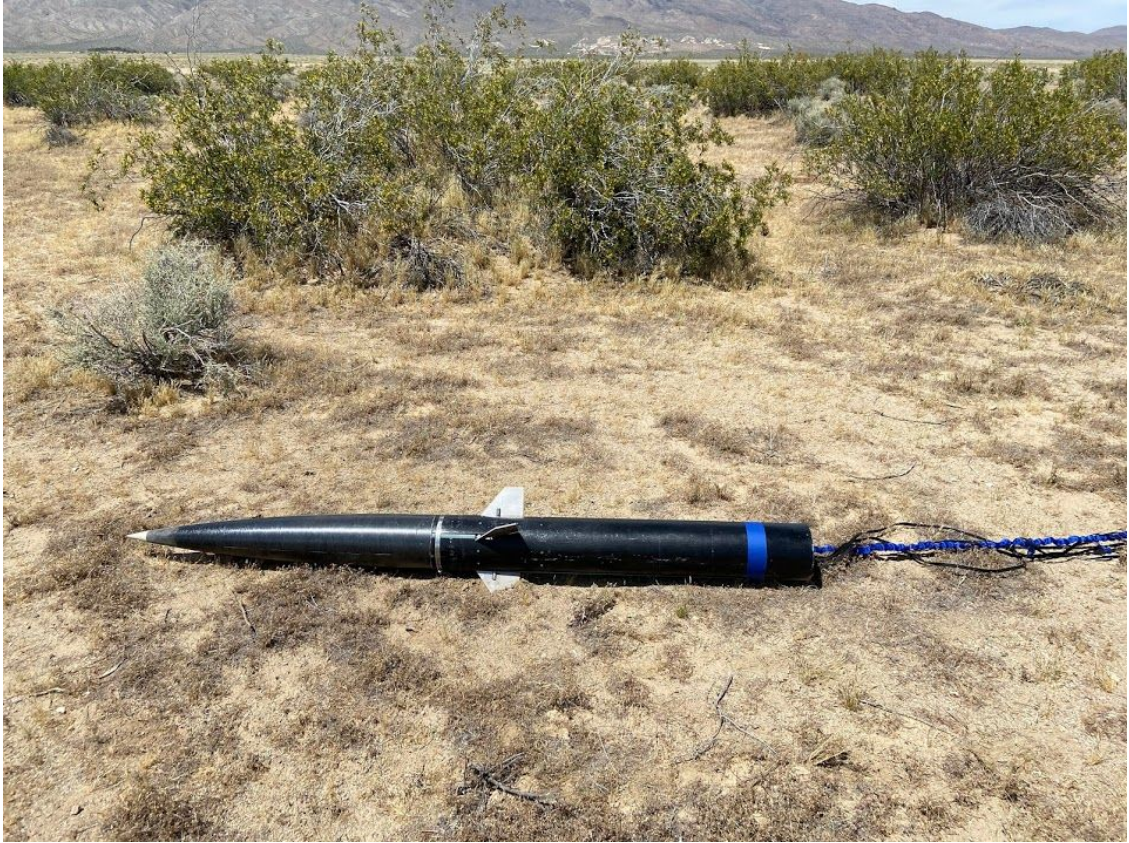
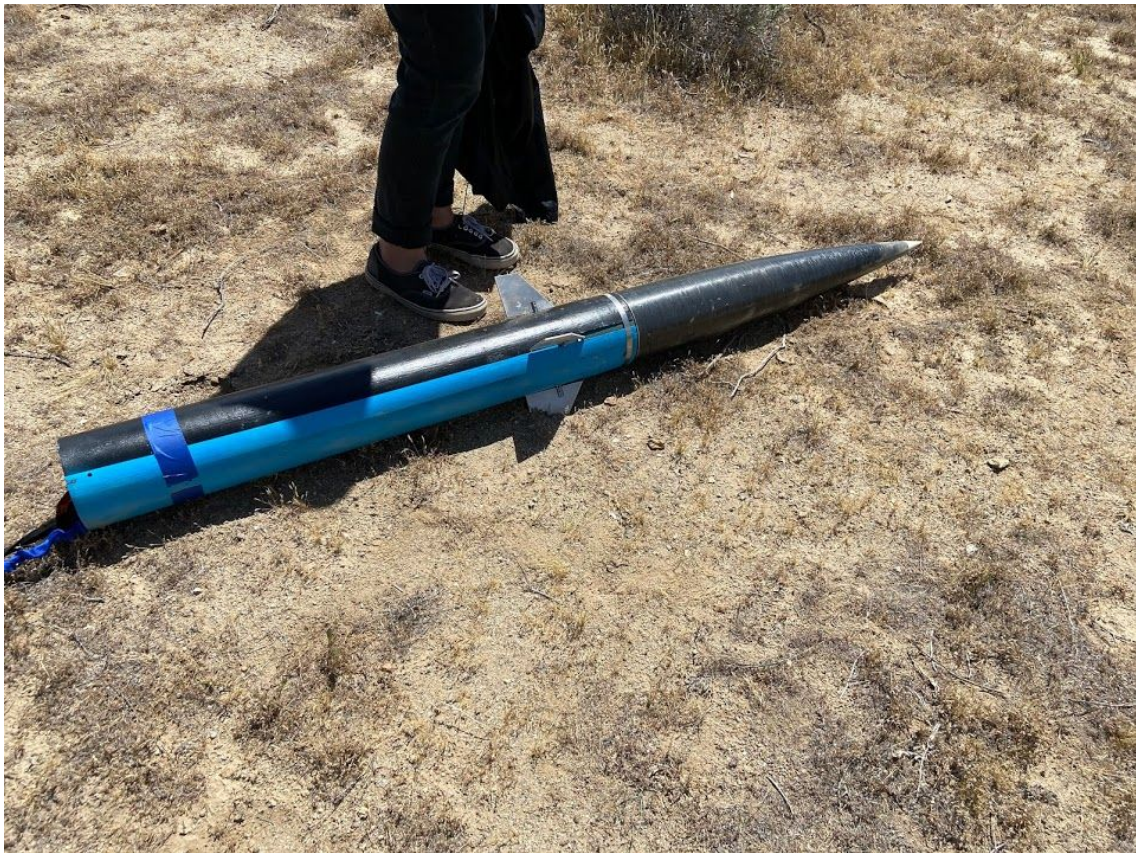
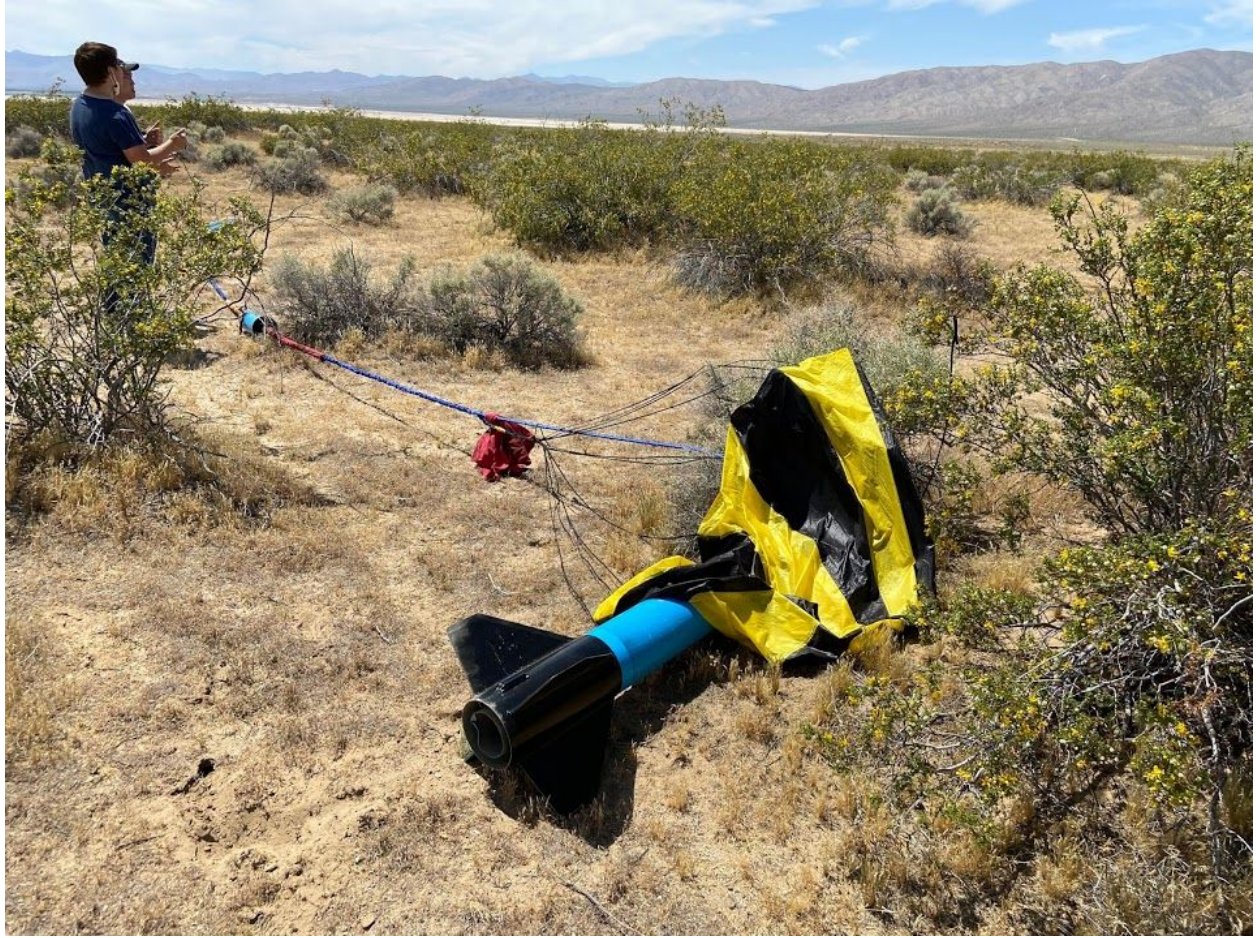
Recovery Analysis

Recovery: The rocket was almost successfully recovered, there were issues with the main parachute in coming out of the rocket due to a snag. The drogue parachute was designed to be oversized in the event of main failure and allowed the rocket to land without major damage.

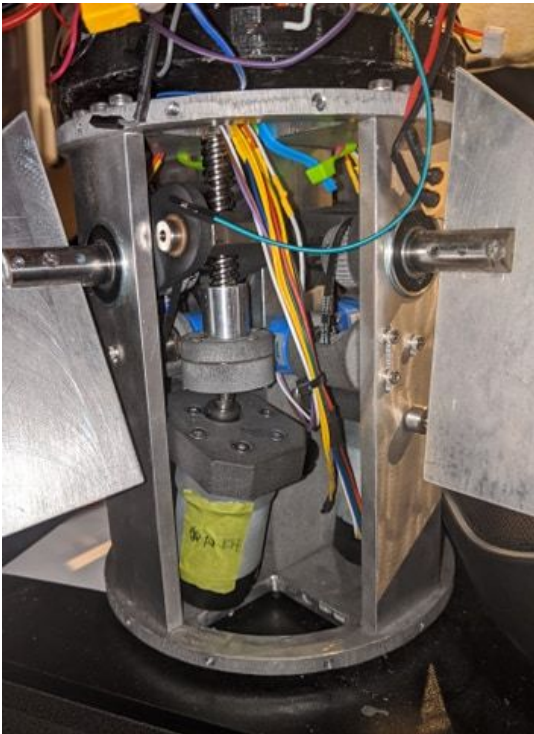
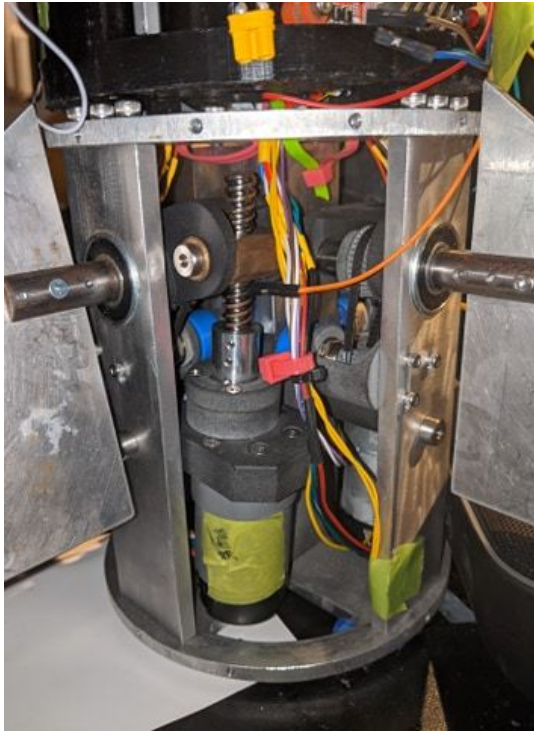
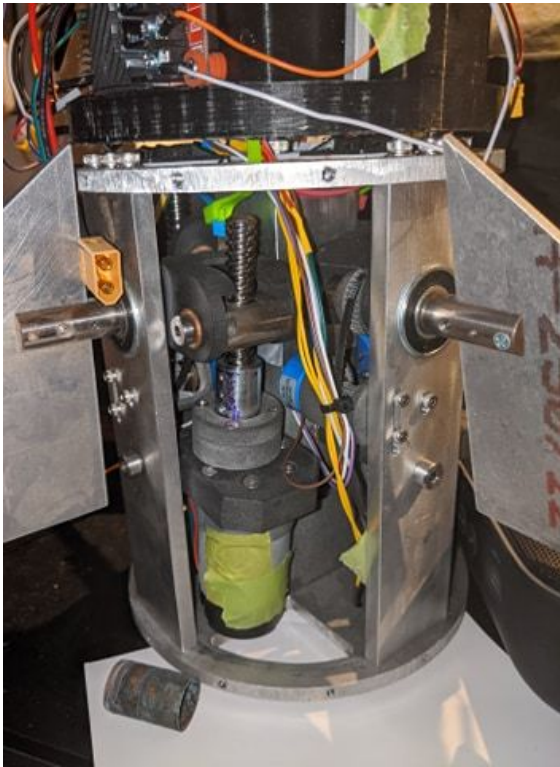
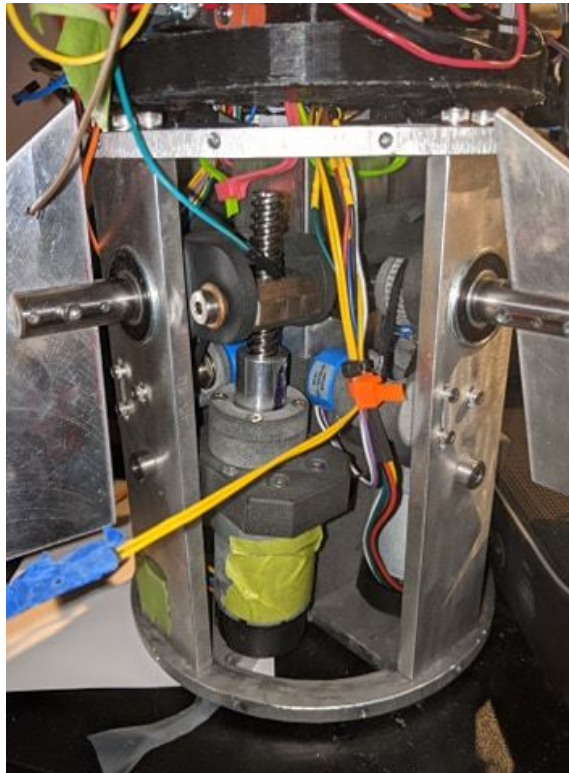
Damage Analysis
(DO NOT SHARE)

Damage Analysis: The rocket structurally survived the landing, however the electronics bay coupler was dented and will possibly require a replacement, however all major parts are safe and almost ready to re-fly.
